INFRARED INSPECTIONS INC.

Scan Date: 08/01/06 Job No: 06113R-06-12 Client: C.E. Crowley & Associates, Inc.

ENERGY LOSS DATA

Location: Image No. 12 is a view of the 3rd floor mechanical room wall/ceiling

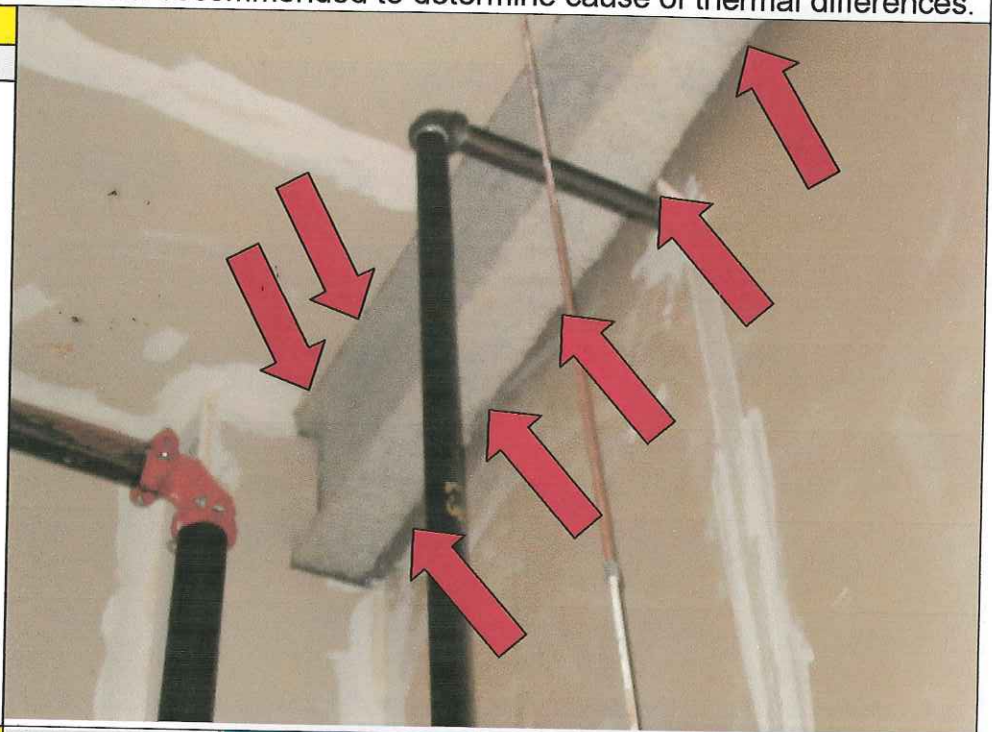
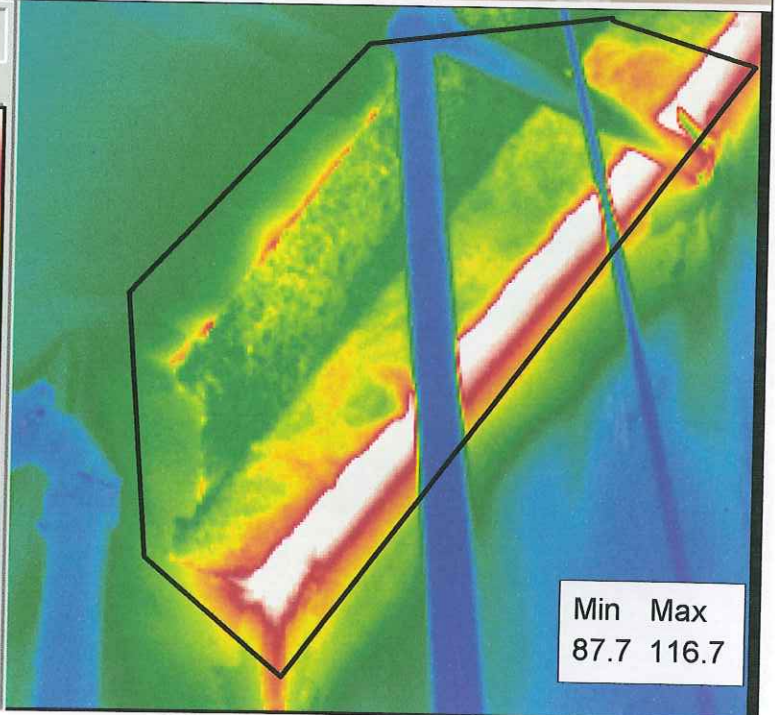
Description: Image(s) document location (see red arrows in top photo) of building surface thermal differences caused by warm air infiltration. See (below) thermal color photo. Investigation of this area is recommended to determine cause of thermal differences.

Thermal air leakage differences may be caused by missing and/or poorly fitted insulation, caulking, seal deficiencies or construction design.

Min Max
87.7 116.7

Note: Investigation of this area is recommended to determine if corrective action is warranted.
